SUBSEA CLAMP+SLEEVE

FOR BUCKLED PIPE

SUBSEA CLAMP+SLEEVE FOR BUCKLED PIPE

CASE STUDY

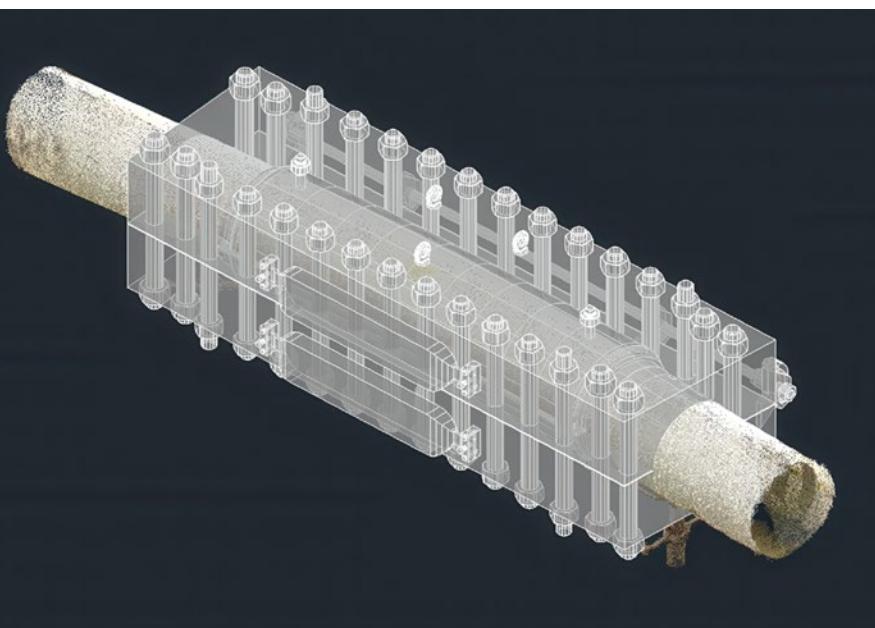
This model was then 3D laser scanned using a state-of-the-art measuring system, enabling PLIDCO®'s engineering team to design and manufacture its custom Clamp+Sleeve fitting.

With approximately 49 inches between seals and a maximum allowable operating pressure of 1,500 PSI, PLIDCO®'s 10x72-inch Clamp+Sleeve fitting included a four-degree horizontal bend in its annulus, along with integral clamping ends to resist end pull and axial stresses. The selected elastomer seal material was compatible with crude oil and could withstand temperatures ranging from -20 to 225 degrees Fahrenheit. Designed to ASME Section VIII to ensure load transfer to the fitting, the custom Clamp+Sleeve also

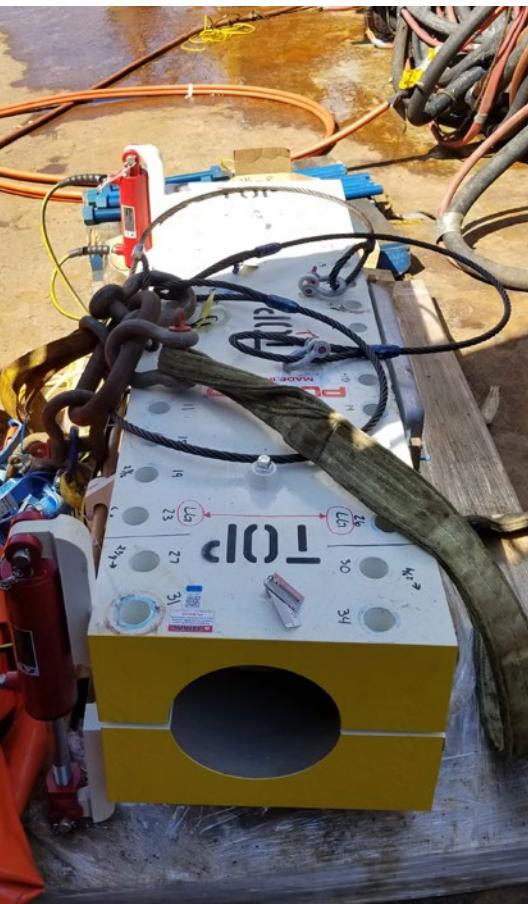
included lifting lugs, marine epoxy coating, xylan-coated studs/nuts and sacrificial anodes, as well as two one-inch vents and plugs per half.

In addition, a custom hydraulic closure system was designed so the fitting could be installed horizontally in the open position, with the top half pivoting on a hinge to bring the bottom half in line. This feature not only ensured proper positioning of the fitting, but also provided a safe work environment for the divers. Once the fitting was properly torqued and secured on the line, it was then hydro-tested – enabling the pipeline to remain in service, while avoiding costly shutdowns.
