RESTORING OFFSHORE OPERATIONS WITH ROV-INSTALLED PIPELINE REPAIR IN ANGOLA

CLIENT:
Stapem Offshore

INDUSTRY:
Subsea Oil & Gas

LOCATION:
Offshore Angola, Atlantic Ocean

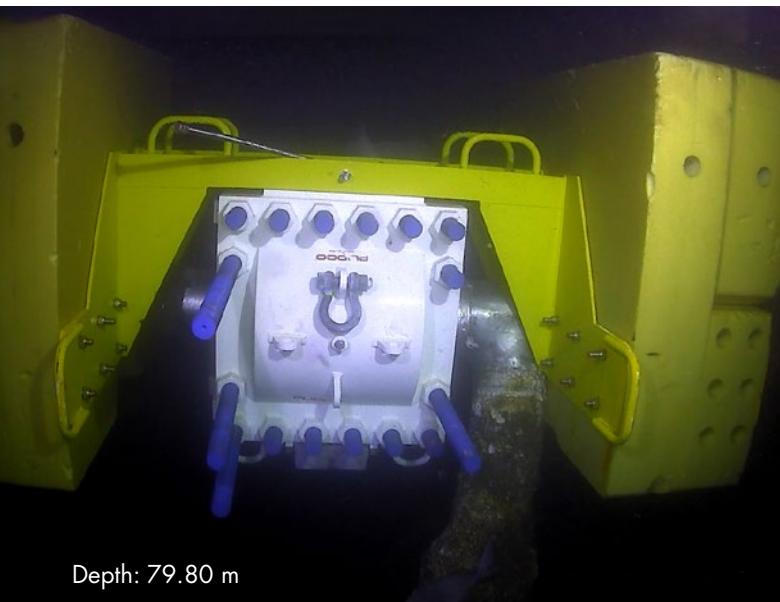
PLIDCO®, a global leader in pipeline repair and maintenance fittings, was selected to design and fabricate a custom clamp solution capable of remote subsea installation. After initial discussions and review of the site conditions, PLIDCO® recommended a Flange Repair Split+Sleeve—a high-integrity fitting engineered specifically for this type of application.

The design process began with dimensional data provided by Film-Ocean and validated using 3D photogrammetry. This advanced imaging provided accurate, high-resolution measurements of the pipe's outer diameter, flange face, stud lengths and ovality—details that would have been

difficult to measure reliably using conventional tools. This ensured that the final fitting would precisely match the existing flange assembly, eliminating the risk of installation misalignment.

The fitting was custom built to ASME Section VIII Division 2 standards at PLIDCO®'s facility in Strongsville, Ohio. It fully encapsulated the damaged 10" ASME B16.5 900# flange set and was engineered to form a pressure-tight seal—without any need for welding. To protect against long-term corrosion, the fitting featured a marine epoxy finish, coated studs and nuts, and attached anodes for cathodic protection. The sealing elements were carefully selected for compatibility with the temperature and fluid characteristics of the injection line.

To accommodate remote handling and reduce installation complexity, the fitting was integrated with a Walker Subsea buoyancy attachment. This addition reduced the fitting's effective weight underwater, allowing it to be safely maneuvered into place by an observation-class ROV.
